SIGIR INSPECTIONS

Project Assessments: Findings at a Glance

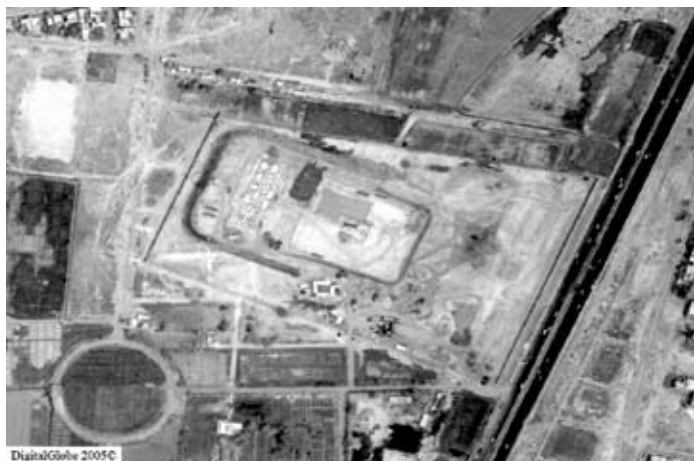
SIGIR found that construction from project start though July 3, 2006, appeared to meet the requirements of the design. The workmanship was adequate to construct the courthouse complex buildings and other facilities. SIGIR raised concerns about the ceramic tile installation practices and the quality of the water circulation pumps. However, project documentation

Aerial Image 1. Courthouse site on August 10, 2005.

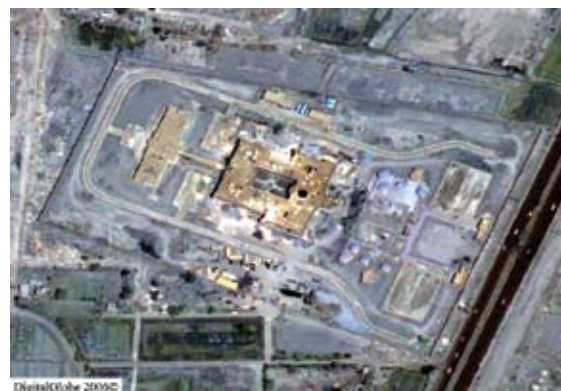
Aerial Image 2. Courthouse on May 16, 2006.

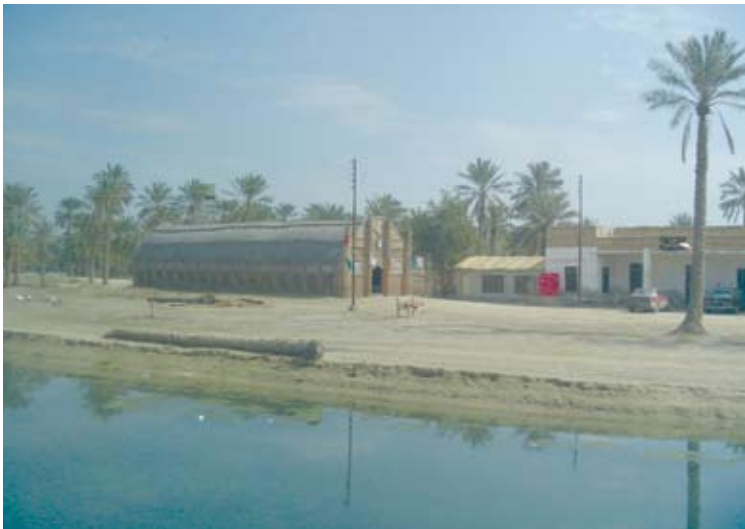
Site Photo 1. Section of Thi-Qar Village Road before construction.
(Photo provided by USACE)

The USACE Resident Office had dispatched a Quality Assurance Representative (QAR)—a local Iraqi national—to the project site to inspect the Thi-Qar Village Road and to take pictures showing current conditions. SIGIR's assessment team reviewed the photos (Site Photos 1 and 2). Minor discrepancies noted during the inspection process do not appear to have adversely affected the overall condition of the road. The summary prepared by NGA

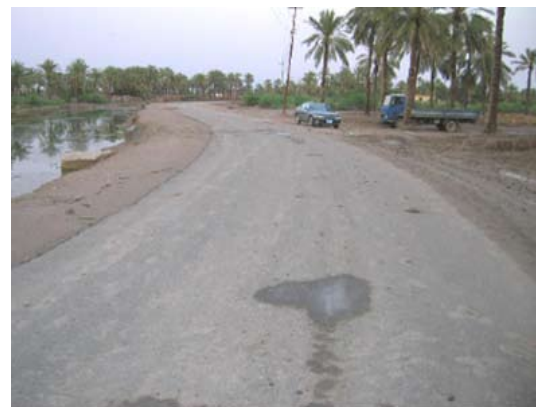
Site Photo 2. Section of Thi-Qar Village Road after construction.
(Photo provided by USACE)

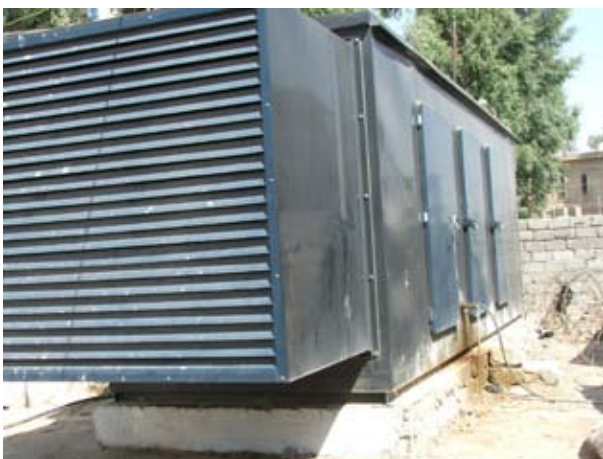
On February 20, 2006, the contractor reported, “Today we operate generator with new wiring and connections.” However, the contractor merely delivered the generator—without starting or load-testing it (Site Photo 18). U.S. Army personnel familiar with the history of the generator attested that IP personnel placed the generator on a concrete pad and installed an old fuel-truck tank to supply the generator (Site Photos 19 and 20). At the time of the assessment team’s August 3, 2006 site visit, the generator was non-operational.

Site Photo 19. Final site where generator was placed by Iraqi Police (IP).

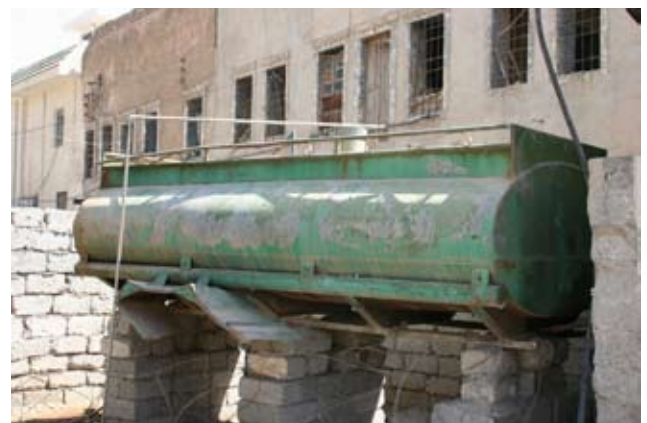
Site Photo 20. Old fuel truck tank placed by IP to supply the generator.

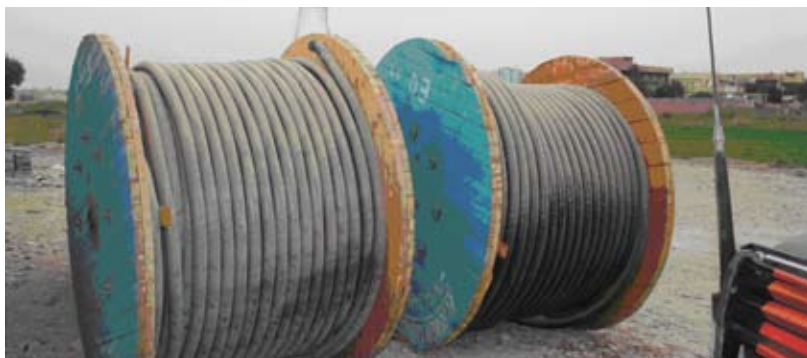
Site Photo 21. 3 X 150 mm² electrical cable supplied on rolls 503 m long. (Photo provided by USACE)

The assessment team verified that the contractor used cable that met Ministry of Electricity standards. Specifically, the cable was an XLPE-insulated 11 kV 3 x 150 mm² cable supplied on rolls 503 meters long (Site Photo 21). Factory tags affixed to each roll documented cable specifications (Site Photo 22).

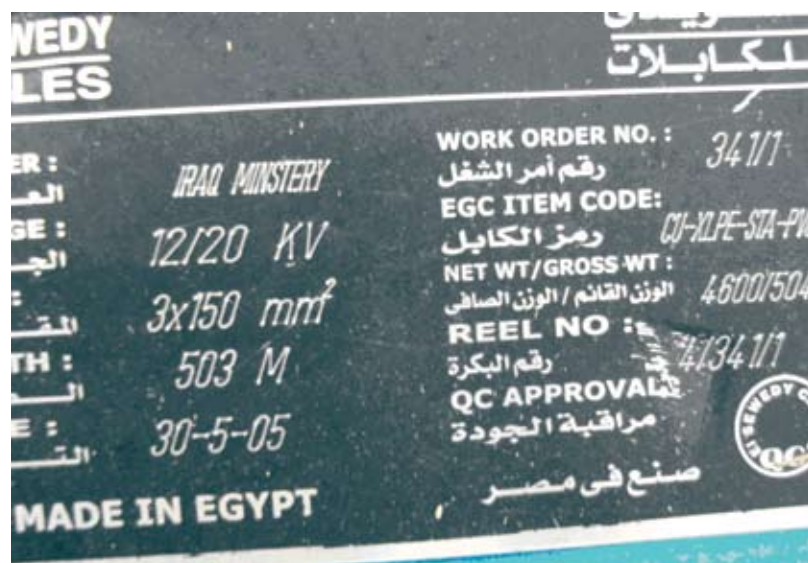
Site Photo 22. Manufacturer's tag documented amount, size, voltage rating, and insulation.

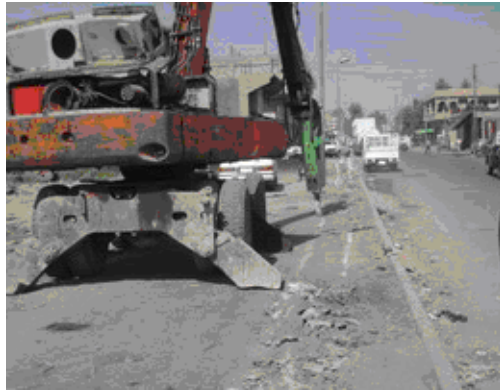
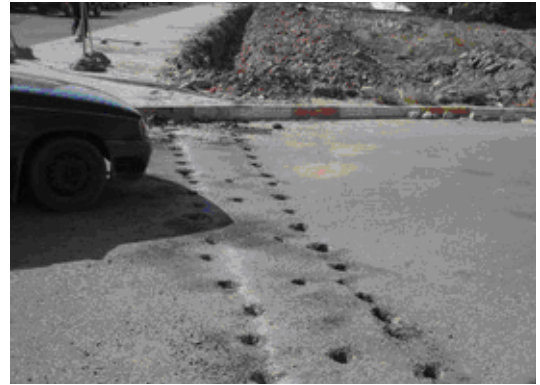
After the route of the cable was surveyed, the surface often required special equipment to break up hard surfaces common to an urban environment before trench excavation could proceed (Site Photos 23 and 24).

Site Photos 23 and 24. Hard surface break-up equipment in preparation of material removal. (Photos provided by USACE)

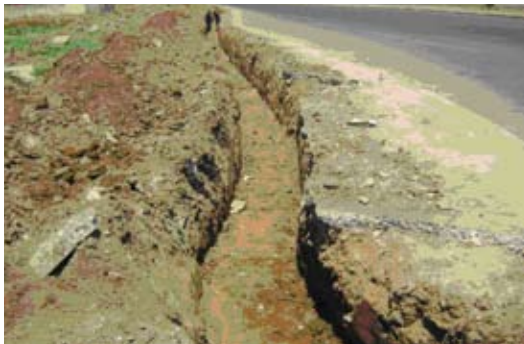
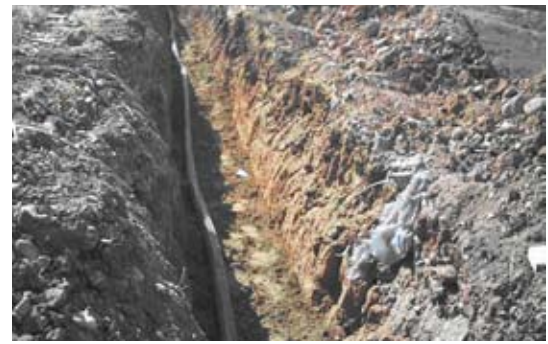
Site Photos 25 and 26. After the trench was excavated and the base compacted (left), the cable was positioned on a sand layer (right). (Photos provided by USACE)

trench to be compacted and made free from stones, with a standard trench depth of 90 cm. The cable was to be placed in the trench on top of 10 cm of smooth sand to provide a cable bedding material (Site Photos 25 and 26).

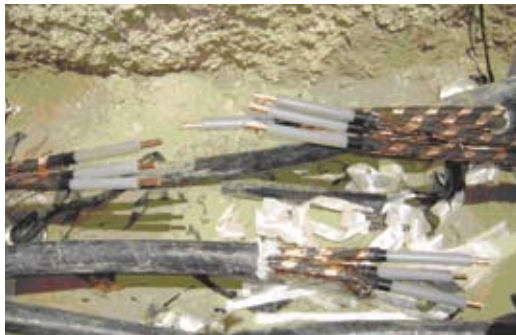
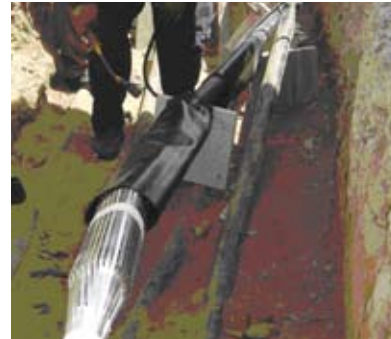
Site Photos 27 and 28. Cables were spliced together with splice kit (left), and heat was applied (right) to shrink outer cover used to protect cable splice. (Photos provided by USACE)

and a shrinkable outer cover that tightened when heat was applied (Site Photos 27 and 28).

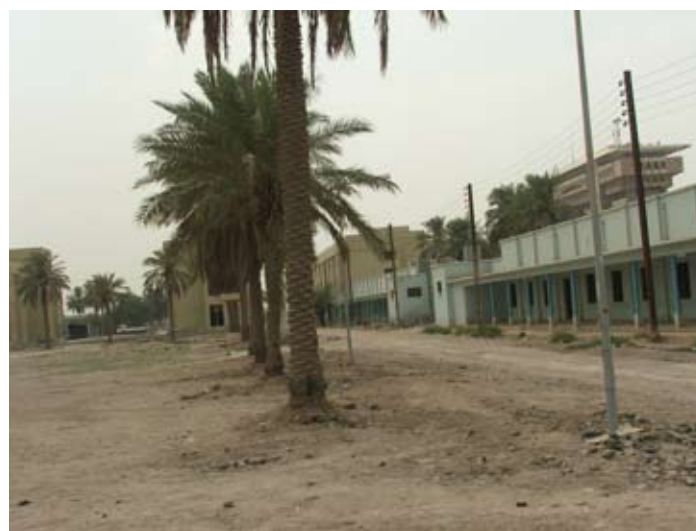
Site Photo 29. Existing barracks at the Baghdad Police College.

The existing facility comprised a number of buildings, constructed approximately from 1935 to 1940, which were in various stages of decay (Site Photos 29 and 30). These buildings had the capacity to house and train approximately 1,200-1,500 cadets. The ultimate goal of the project was to house and train approximately 4,000 cadets.

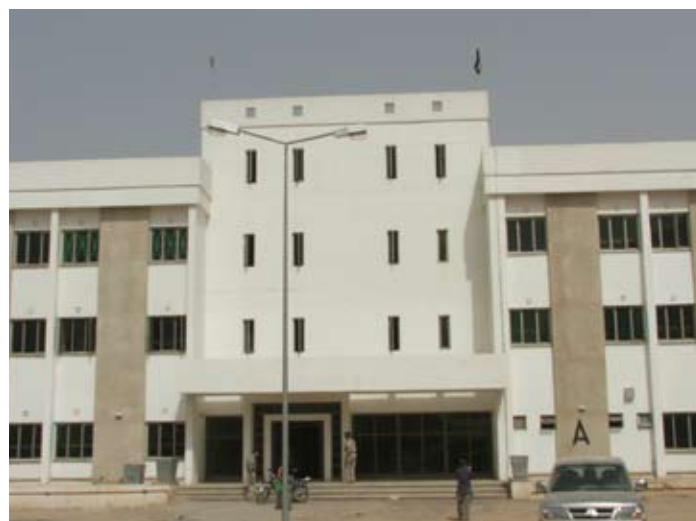
Site Photo 30. Outside view of new cadet barracks building.

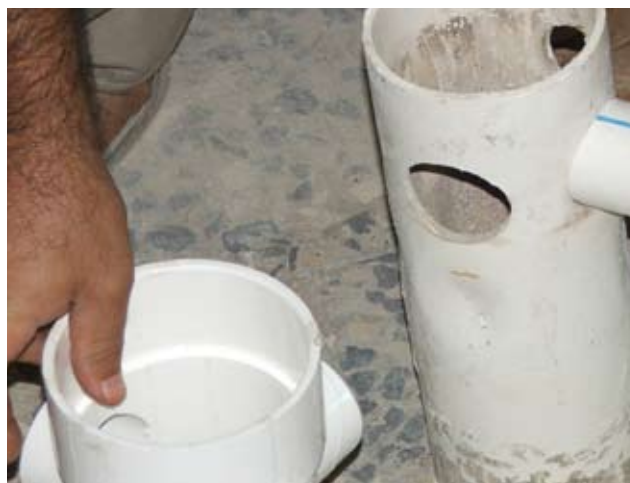
Site Photo 36. Contract-specified wastewater pipe connection is shown on the lower left.

- Drains were assembled without the specified molded plastic fittings, which resulted in water and waste materials flowing from the collection trees through the improperly fabricated joints directly into the concrete floors. The contractor used pipes with holes that were hand-cut with secondary pipes inserted (Site Photo 35), rather than the appropriate type of pipe (Site Photo 36).

As soon as the buildings started to leak from the top floor to the ground floor, the Director of the Baghdad Police College contacted the contractor. The contractor directed the subcontractor who performed the original work to correct the problem. The subcontractor is currently changing the pipes that contributed to the leaks. The subcontractor also plans to use the pipes with molded plastic fittings, such as the one identified in Site Photo 36, which should eliminate water and waste materials from flowing directly onto the concrete floors.

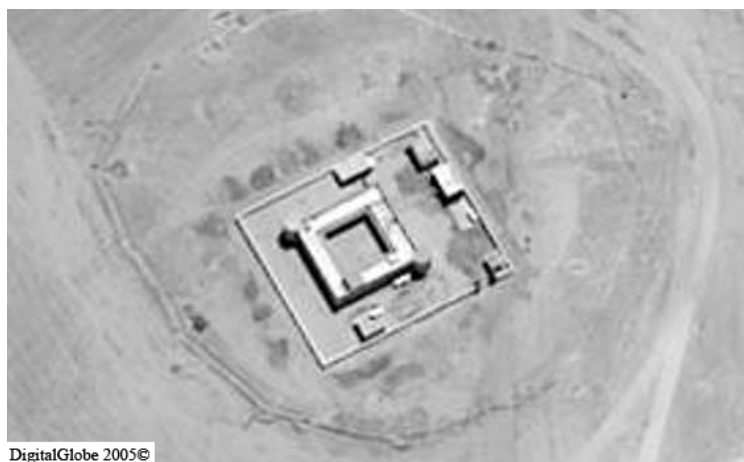
Aerial Image 3. This image provided by NGA shows a completed border fort located along the Iraq/Syria border.

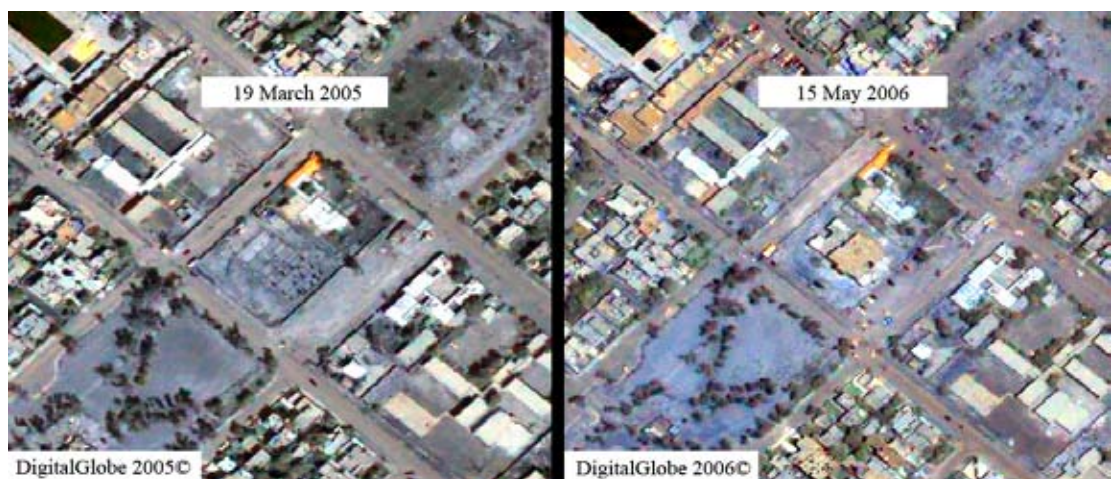
Imagery taken on March 19, 2005, shows the initial construction of the clinic in progress, with the building support beams visible. Imagery taken on May 15, 2006, shows what appears to be the completed clinic structure with vehicles in the parking lot. There are no visible indications that the project is incomplete or will not meet project requirements (Aerial Image 4).

Aerial Image 4. A review of imagery taken between March 19, 2005, and May 15, 2006, shows progress made at the Al Thubbat clinic in Baghdad.

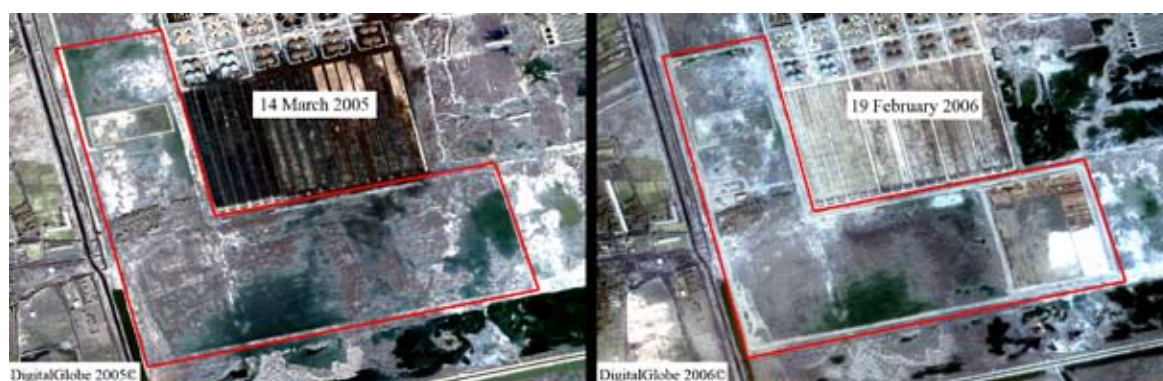
On imagery taken on March 14, 2005, the only noticeable construction is the ground preparation of the Construction Debris Landfill portion of the Baghdad Landfill. Imagery from February 19, 2006, shows what appears to be a completed landfill. Structures visible as of

Aerial Image 5. A comparison of two images taken on March 14, 2005, and February 19, 2006, shows construction progress of the Baghdad Landfill, outlined in red.

February 19, 2006, comprise the Administration and Truck Maintenance buildings. Also noted are the signs of activity in the first Landfill Cell area. There are no visual indicators that this project does not or will not meet mission requirements (Aerial Image 5).
